HARTWELL LAKE PROJECT
Savannah River, Georgia And South Carolina

REHABILITATION OF CLEMSON UPPER DIVERSION DAM

CONTRACT NO. DACW21-83-C-0066

CONSTRUCTION FOUNDATION REPORT

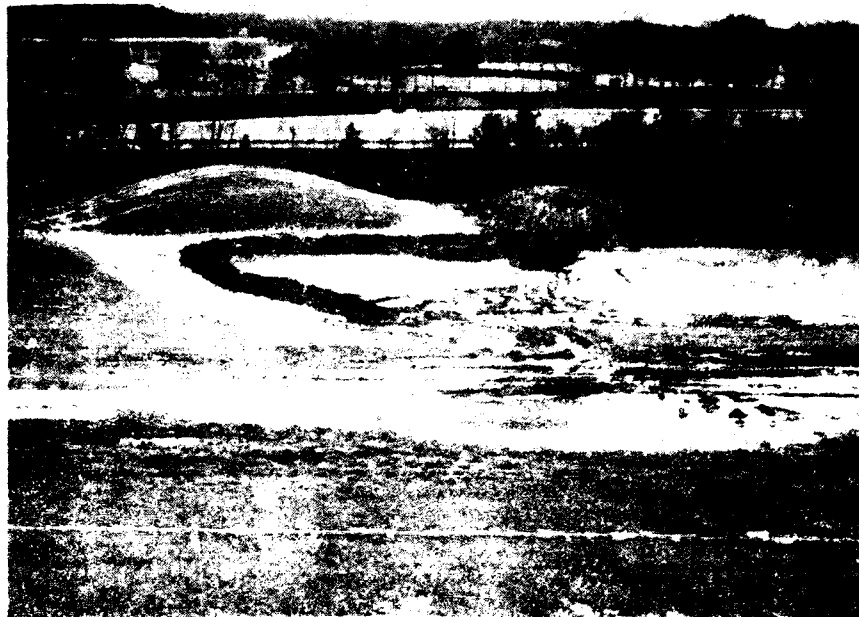
Photo 19 - Stockpile area after heavy rain (November 28, 1980)

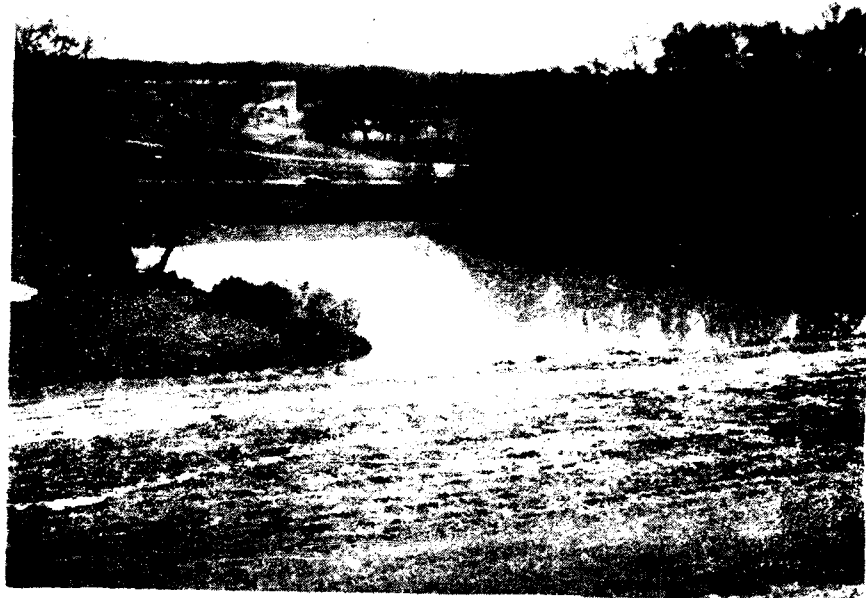
Photo 21 - Seepage pond after heavy rain (November 28, 1983)

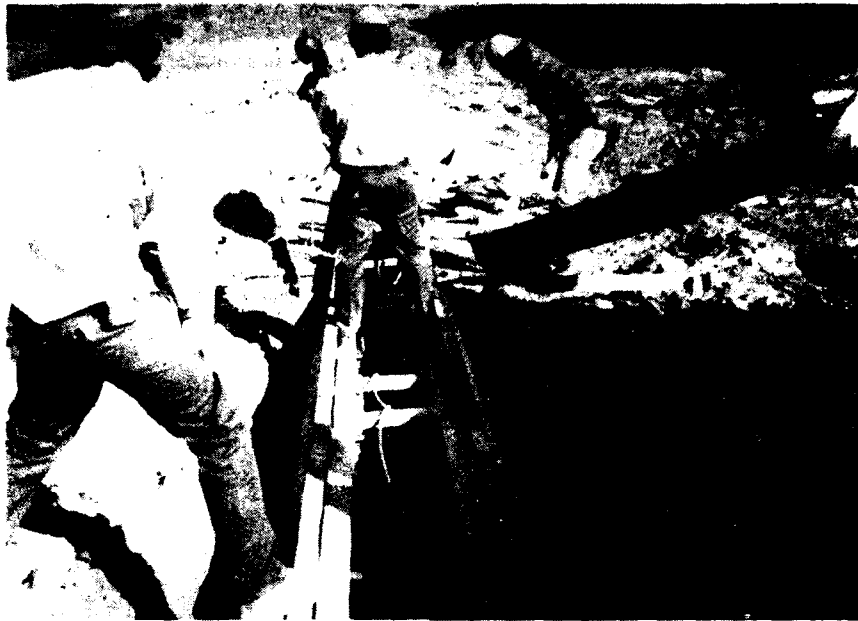
Photo 28 - Placing concrete for guidewall at station 20+25 to 21+30 (January 6, 1984)

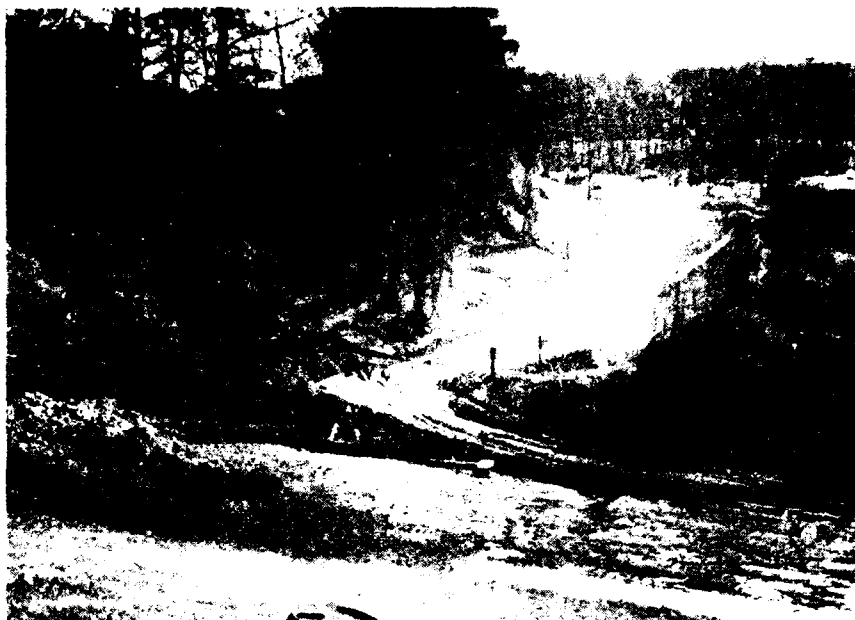
Photo 30 - Initial improvements of haul road (January 29, 1984)

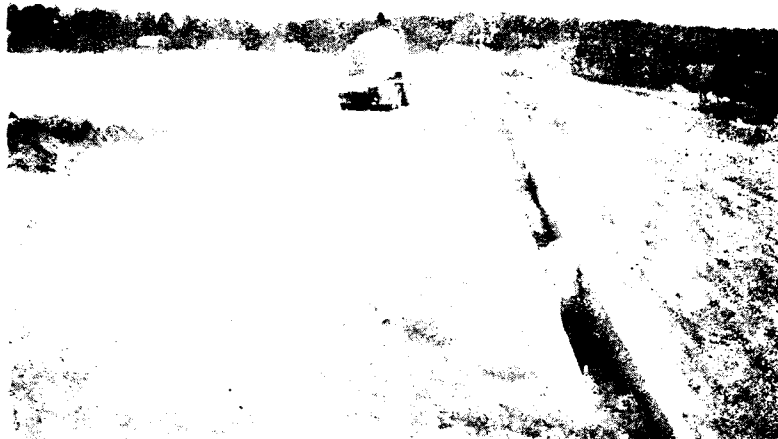
Photo 32 - Haul road improvements (February, 1984)

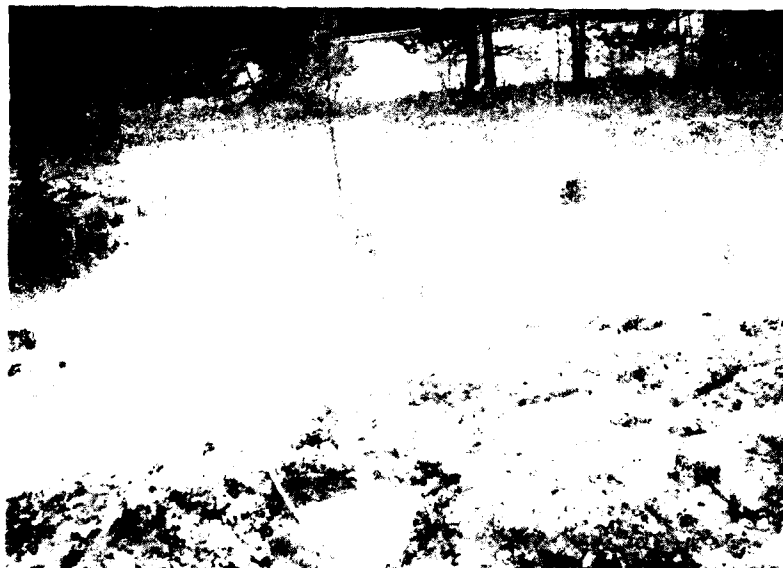
Photo 33 - Overflow of bentonite slurry looking toward Highway 93
from desander (February 10, 1984)

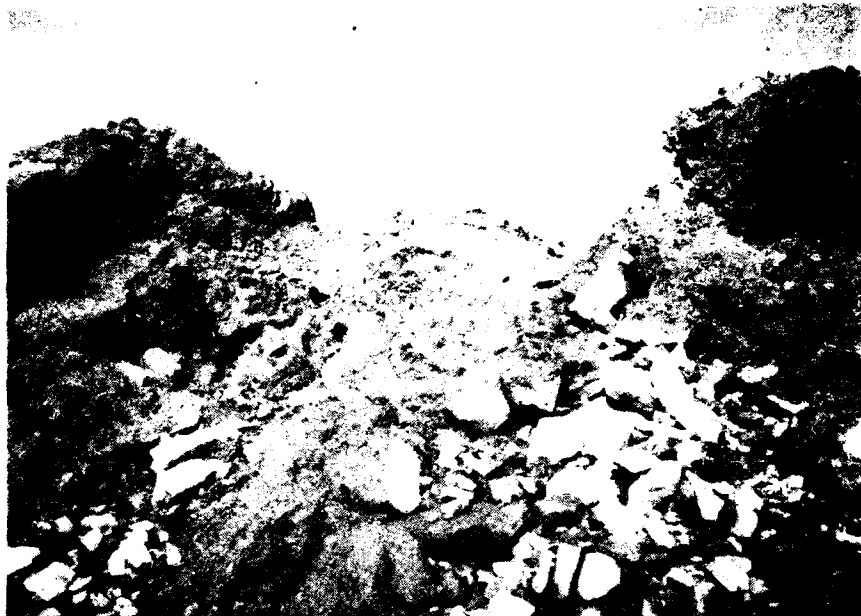
Photo 34 - Wash-out downstream looking upstream towards working platform at station 4+60 (February 29, 1984)

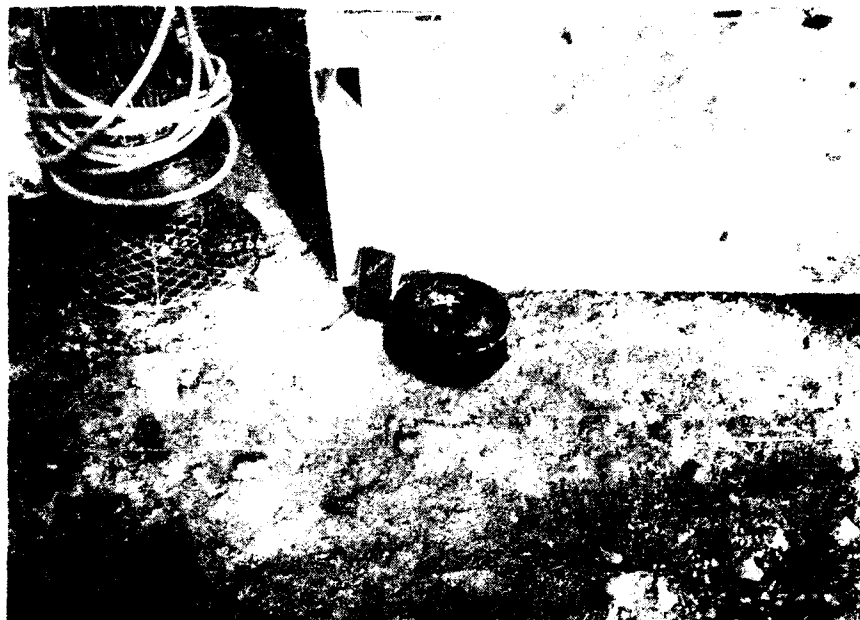
Photo 36 - Go-devil (March 2, 1984)

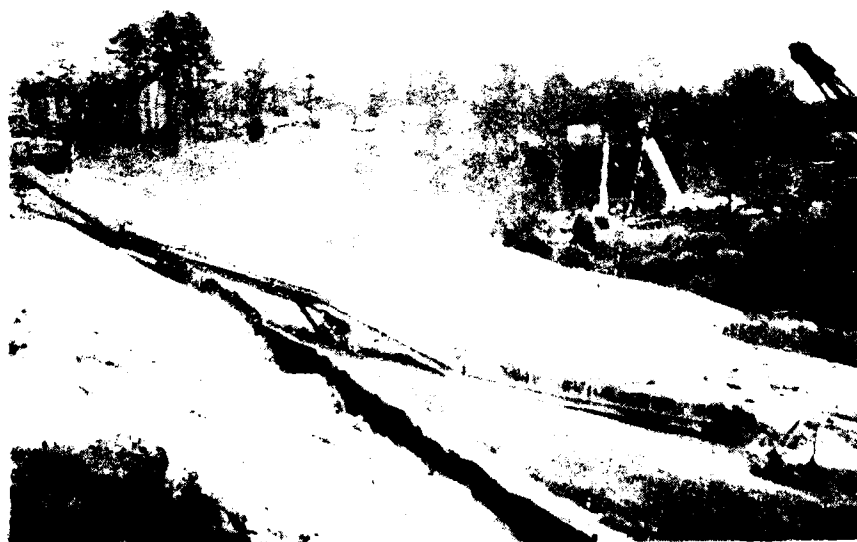
Photo 37 - General overview, note chute in center of photo
(March 2, 1984)

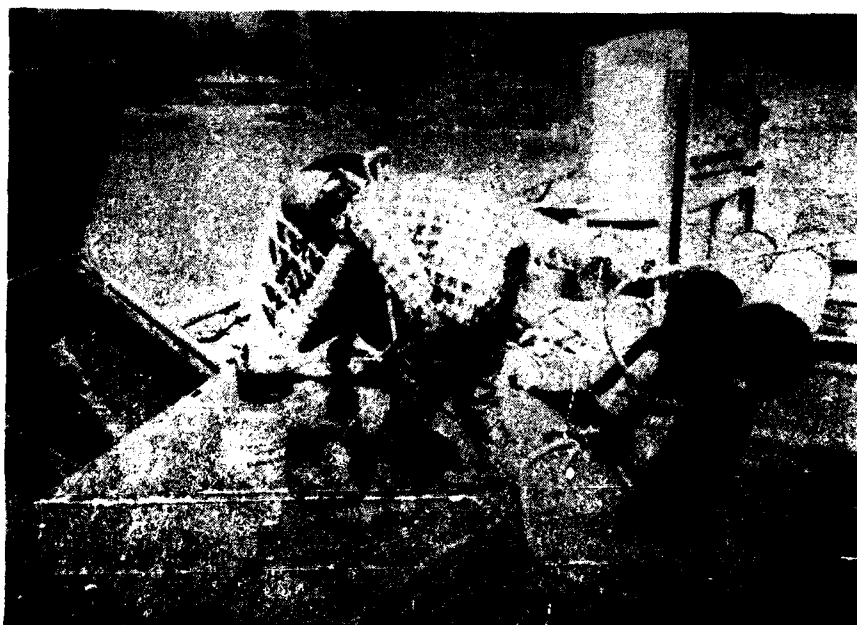
Photo 39 - Contractor checking slump on concrete (March 23, 1984)

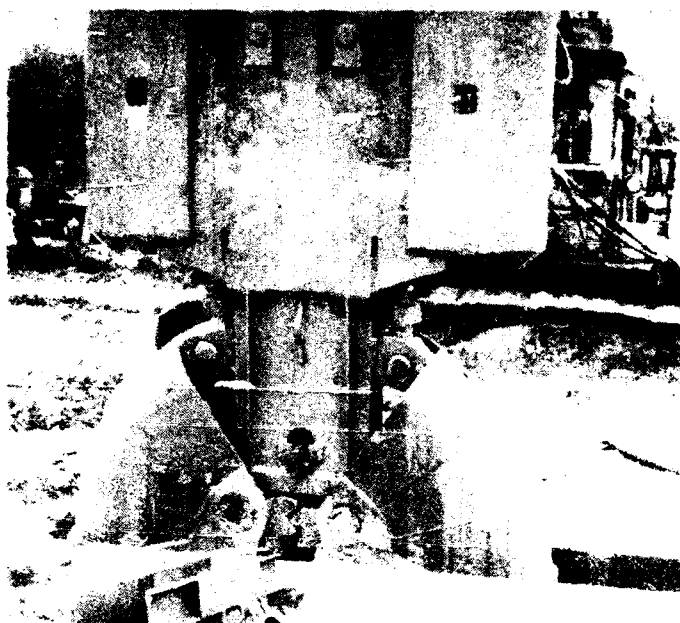
Photo 40 - Excavation of Panel 54 with kelley crane (March 23, 1984)

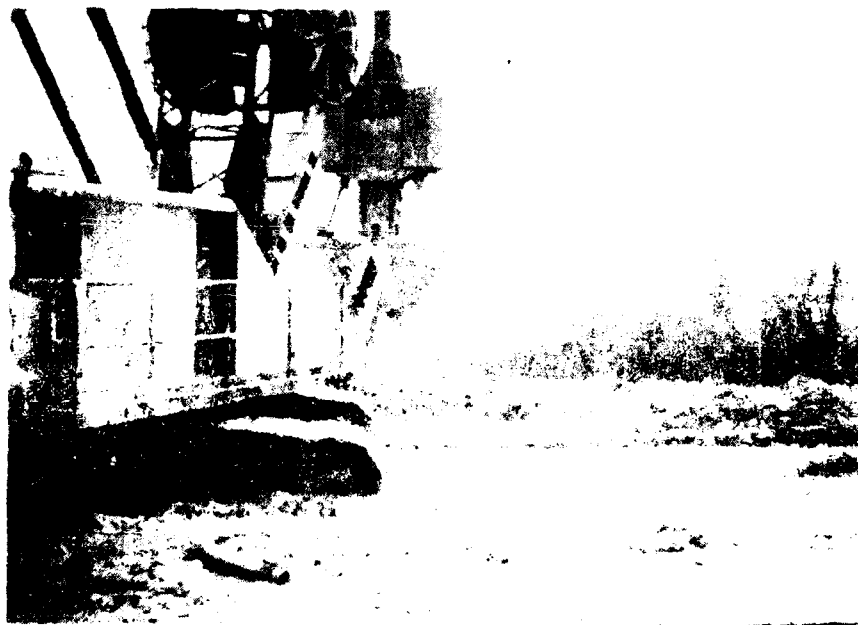
Photo 41 - Excavation of Panel 54 with kelley crane (March 27, 1984)

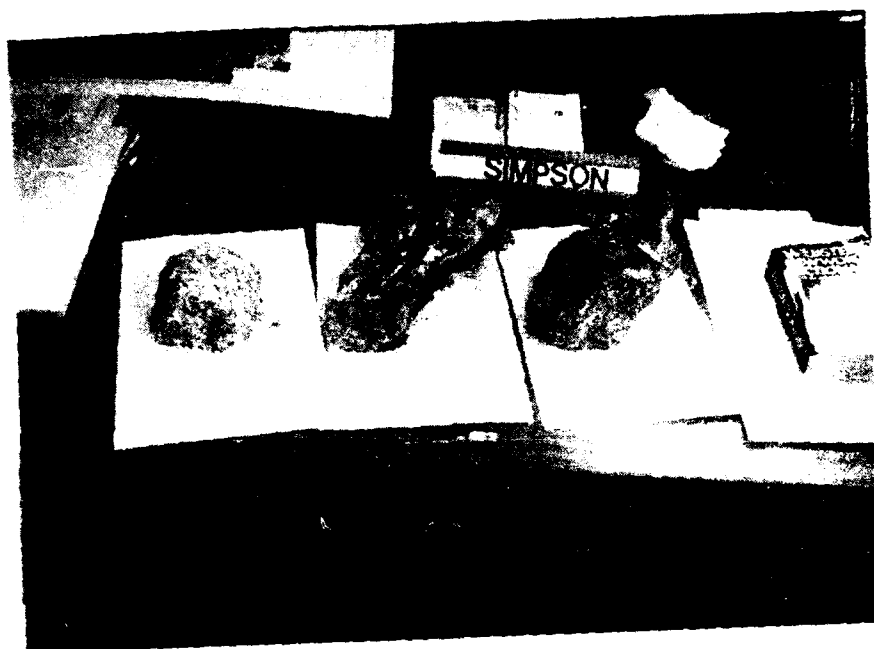
7.1 Observation of Excavated Material: The material that was excavated during cutoff wall construction was comprised of embankment fill, alluvial deposits, saprolite, and crystalline rock. The lithology of these materials is described in Sections 4.2.2 and 4.2.3 of this report. Photo 42 of Appendix A shows some typical rock that was recovered. Much of the rock was saprolitic and highly weathered. Inspectors at the site considered material to be bedrock when rock structure could be distinguished regardless of any discoloration or weathering.

Photo 42 - Rock samples from 86, 89, and 90 feet in Panel 39
(April 4, 1984)

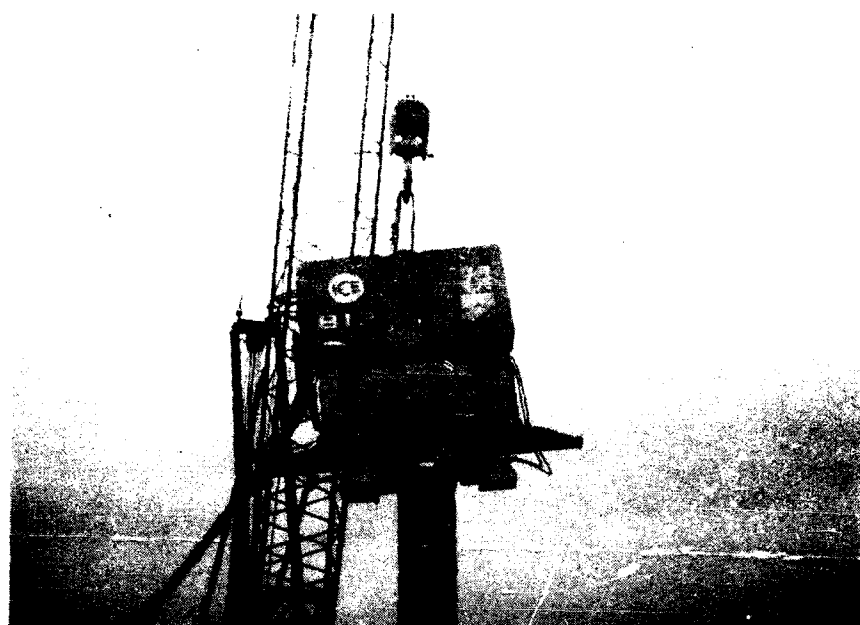
Photo 44 - Vibratory hammer extracting shoulder pipe from Panel 47
(April 5, 1984)

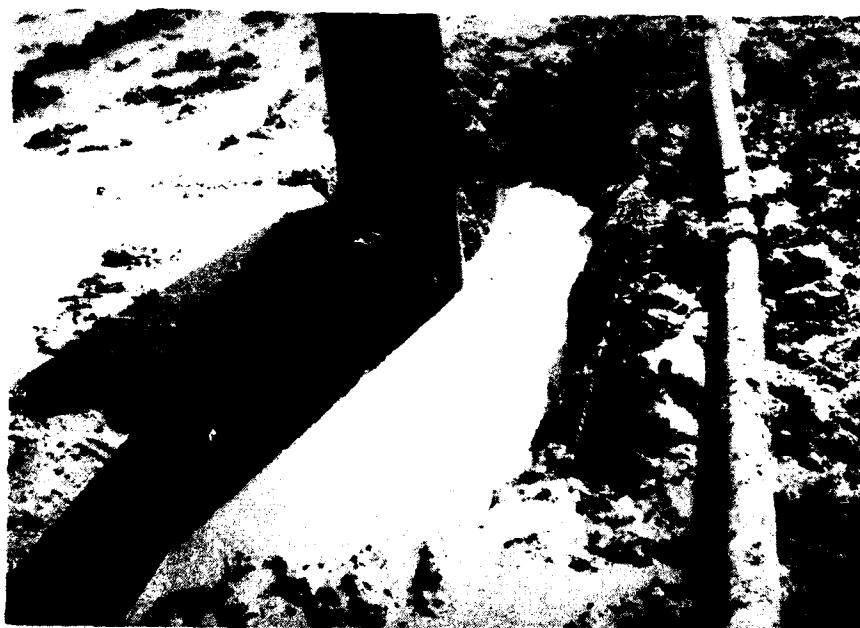
Photo 45 - Excavation around stuck shoulder pipe in Panels 41 and
42 (April 12, 1984)

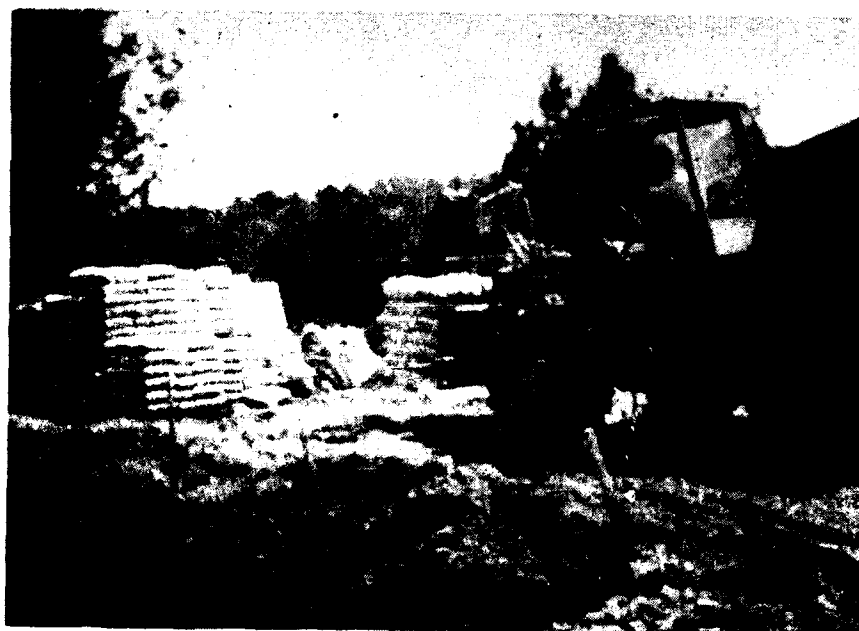
Panel 47 - Unloading bentonite (April 23, 1984)

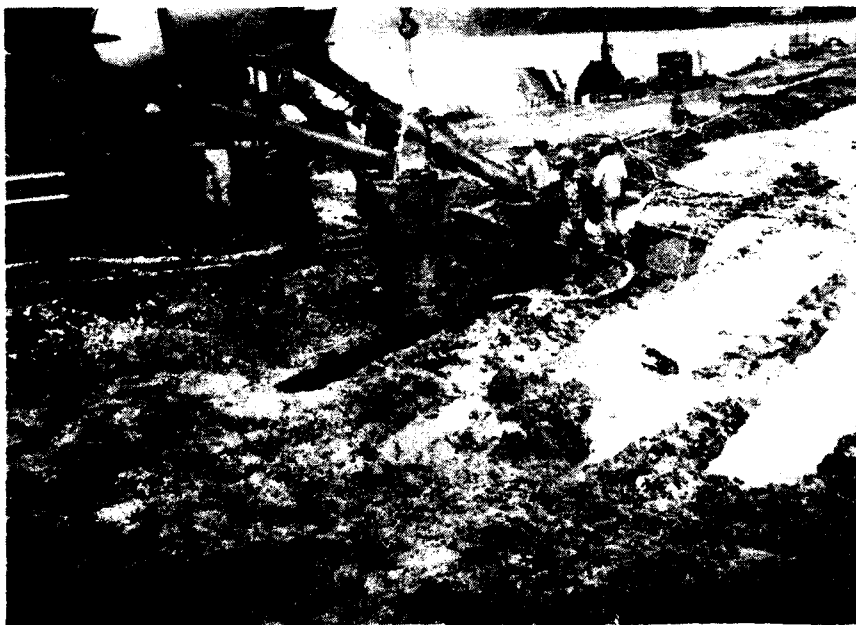
Photo 53 - Pouring concrete in Panel 1 (May 23, 1984)

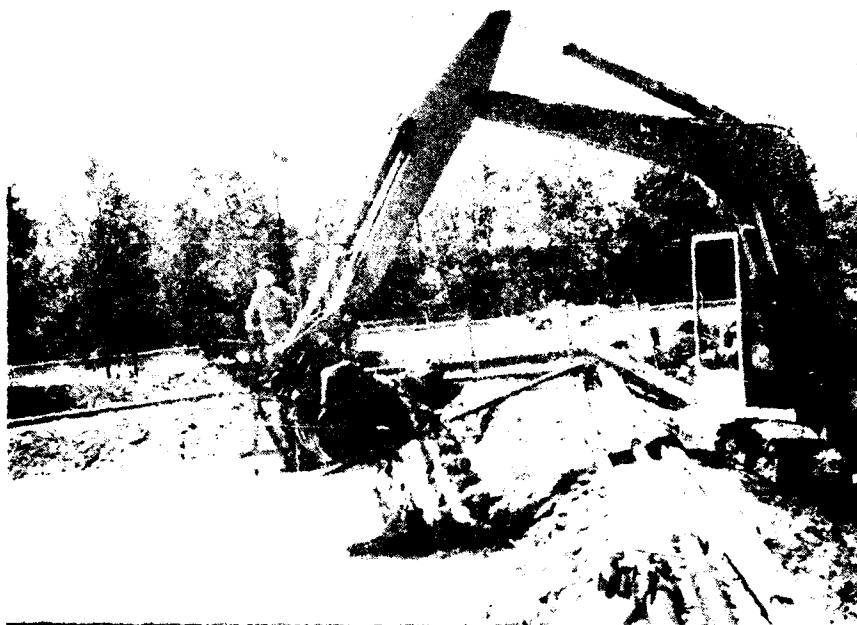
Photo 54 - Cleaning out slurry Pond-B (May 1, 1984)

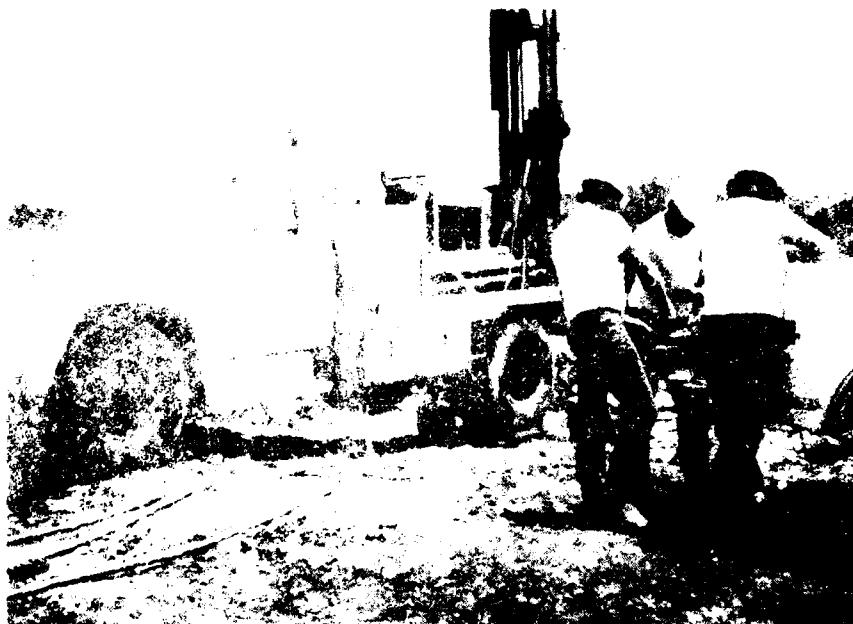
Photo 59 - Second phase of core drilling on Panel 30 (May 23, 1984)

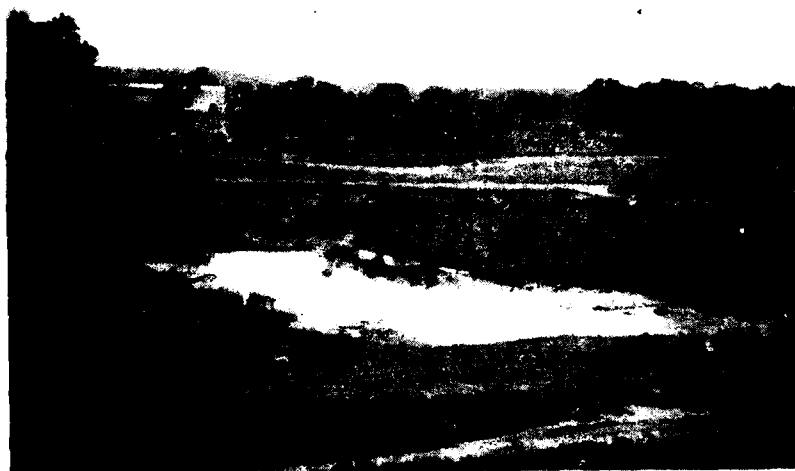
Photo 61 - Area downstream after clearing and grubbing (June 11, 1984)

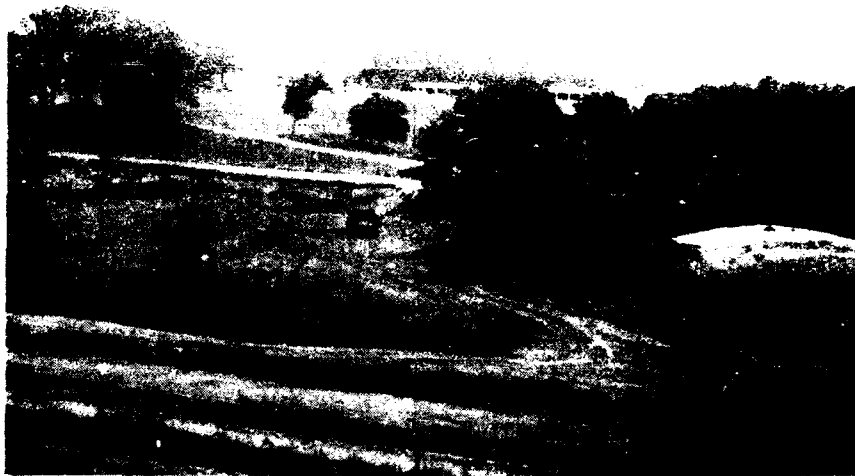
Photo 62 - Clearing and grubbing (June 11, 1984)

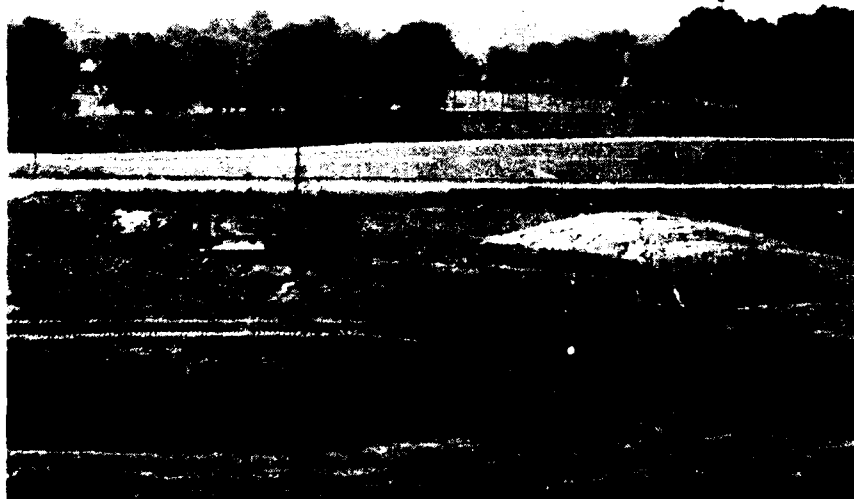
Photo 63 - Cleared area downstream toe (June 1984)

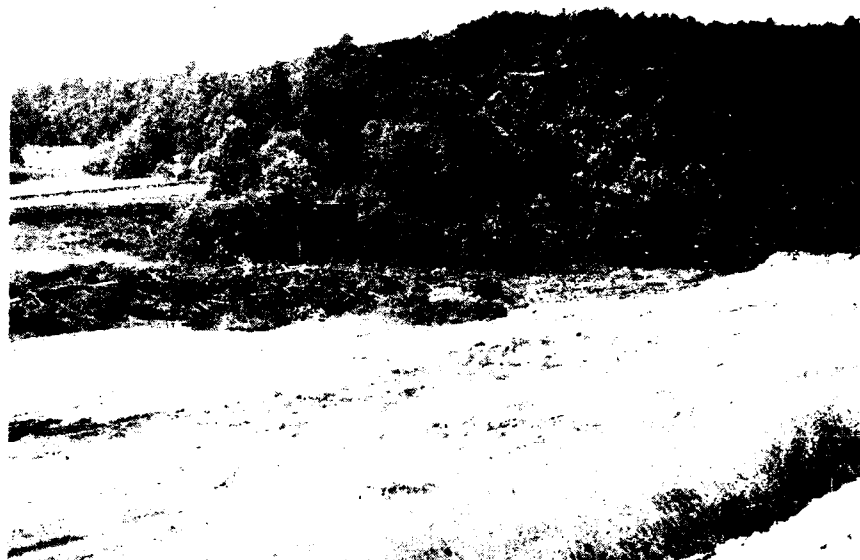
Photo 64 - Cleared area downstream toe (June 1984)

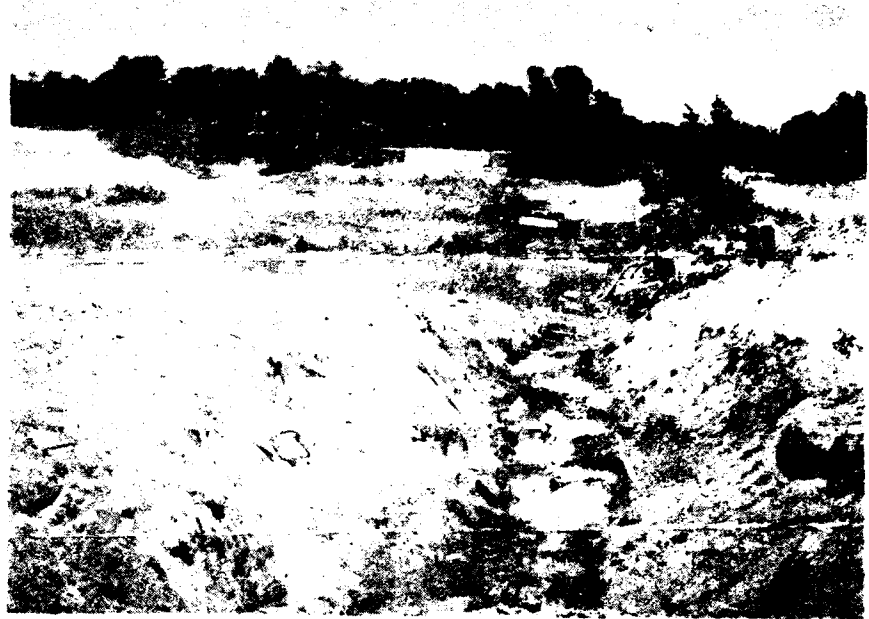
Photo 66 - Cleared drainage ditch (June 14, 1984)

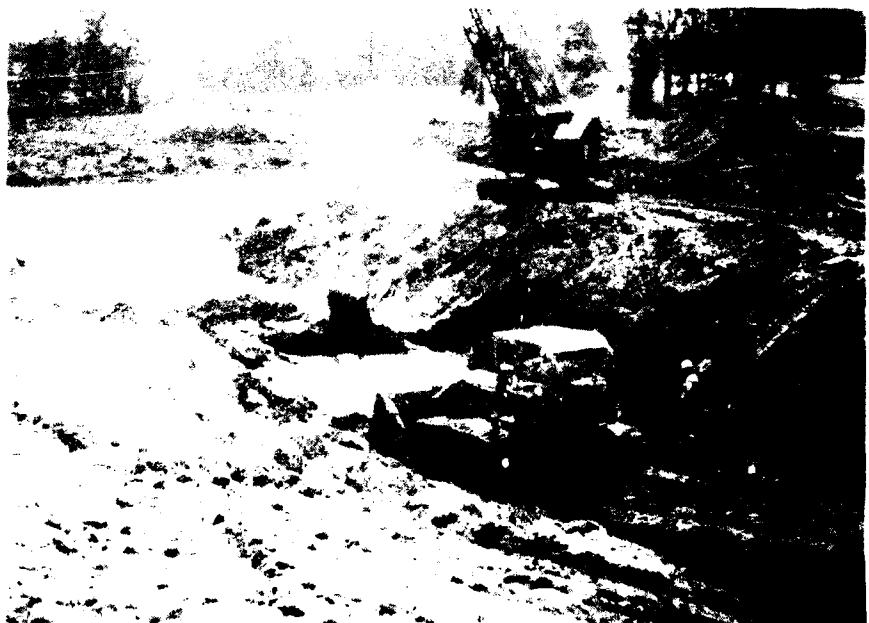
Photo 67 - Pushing into swamp (June 18, 1984)

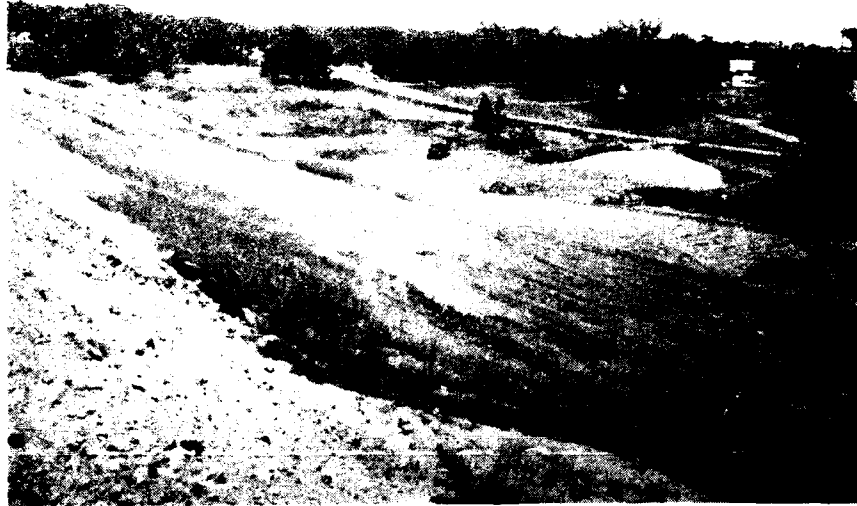
Photo 68 - Overview to the west (June 14, 1984)

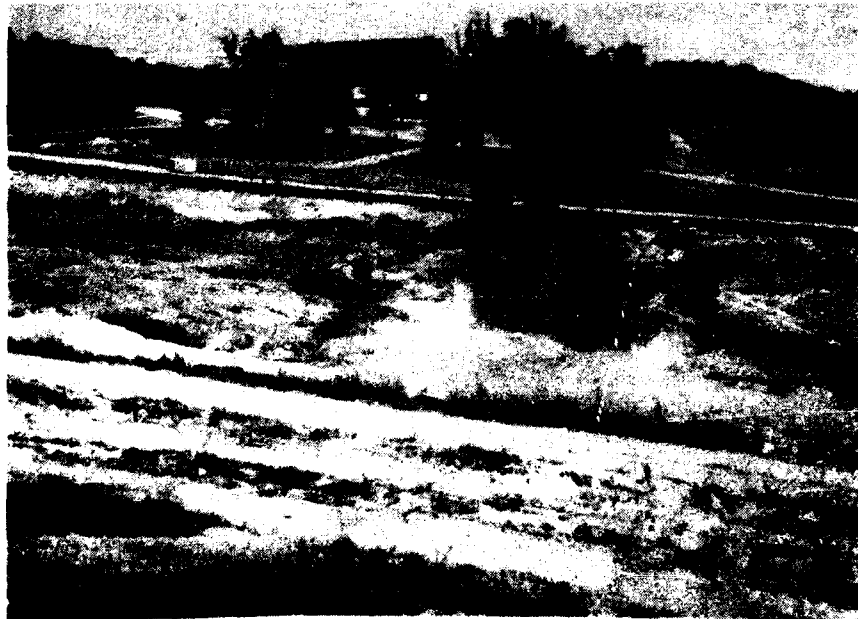
Photo 69 - Overview center of toe area (June 14, 1984)

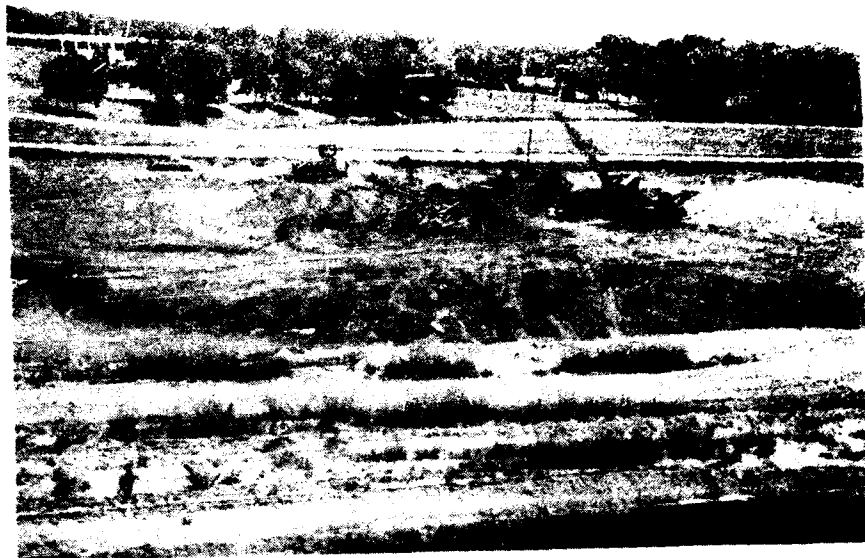
Photo 70 - Overview of toe area (June 14, 1984)

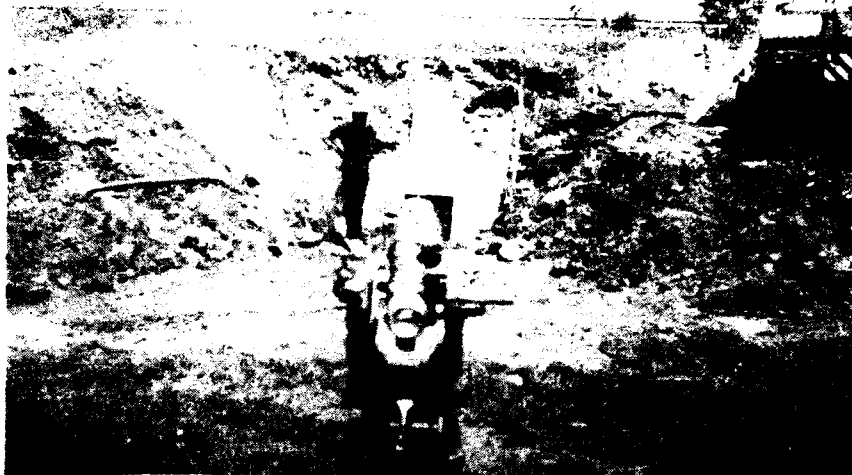
Photo 72 - Alignment for boring under Highway 93
(July 5, 1984)

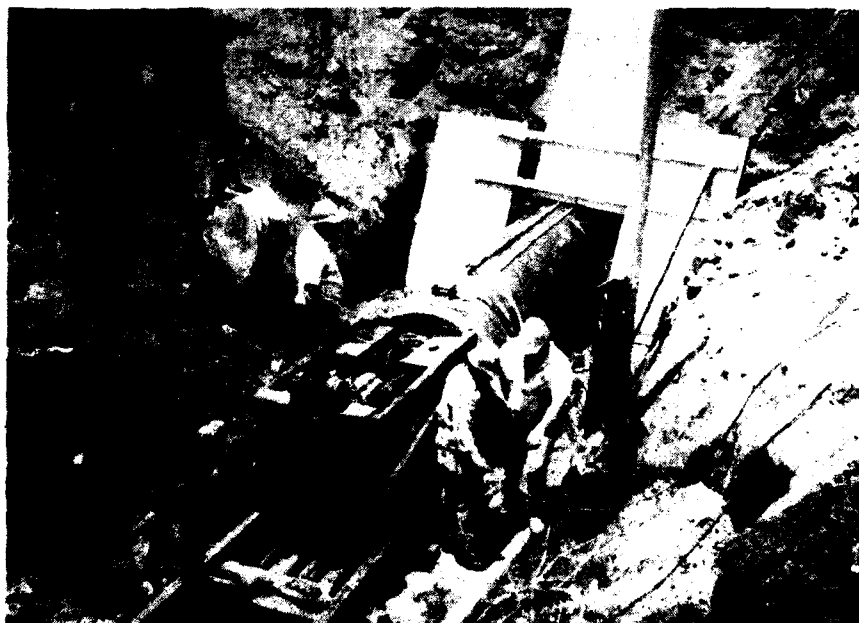
Photo 73 - Boring operations (July 5, 1984)

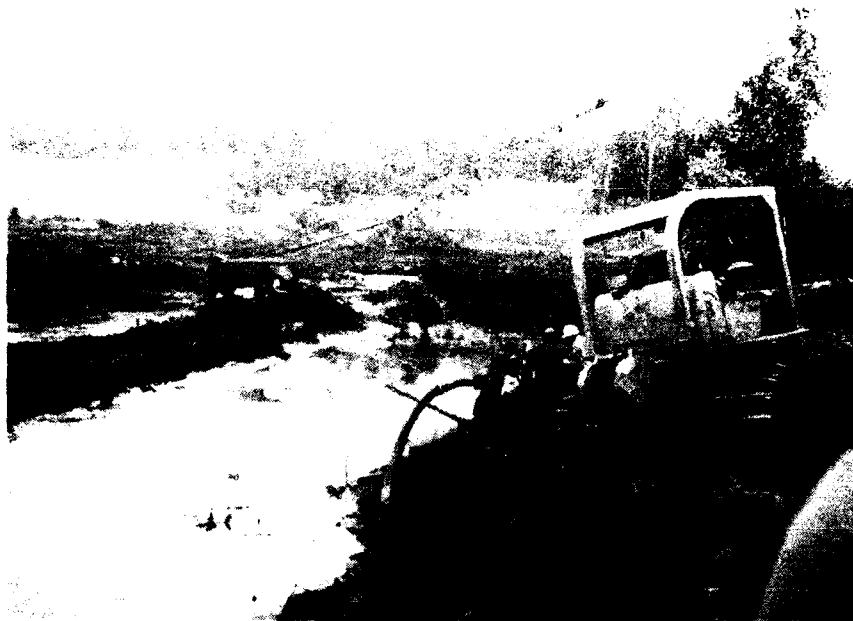
Photo 76 - Mucking swamp (July 2, 1984)

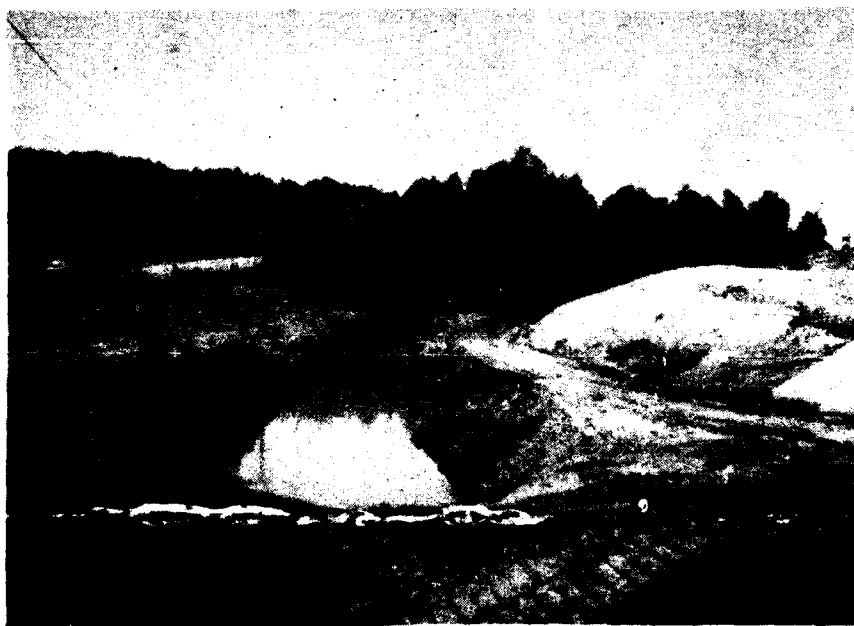
Photo 77 - Drainage ditch after cleaning (July 4, 1984)

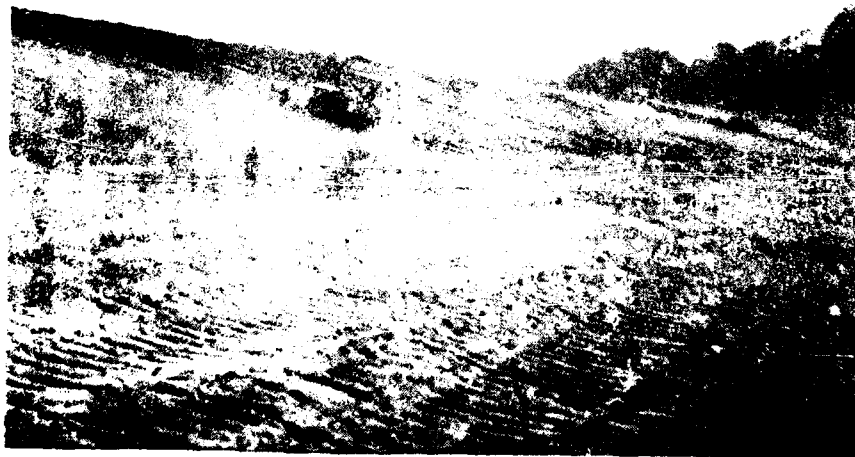
Photo 79 - Pushing topsoil (July 9, 1984)

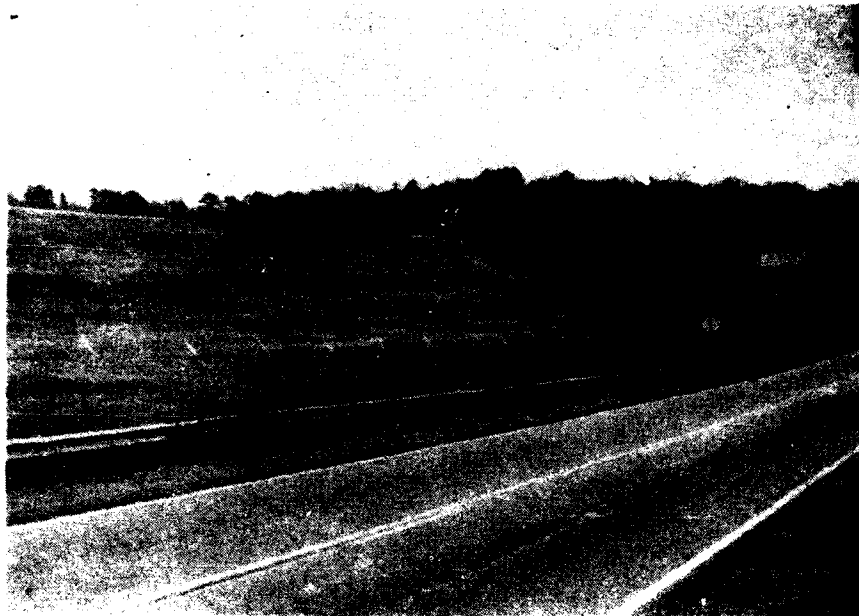
Photo 80 - Overview after site restoration (November 1985)

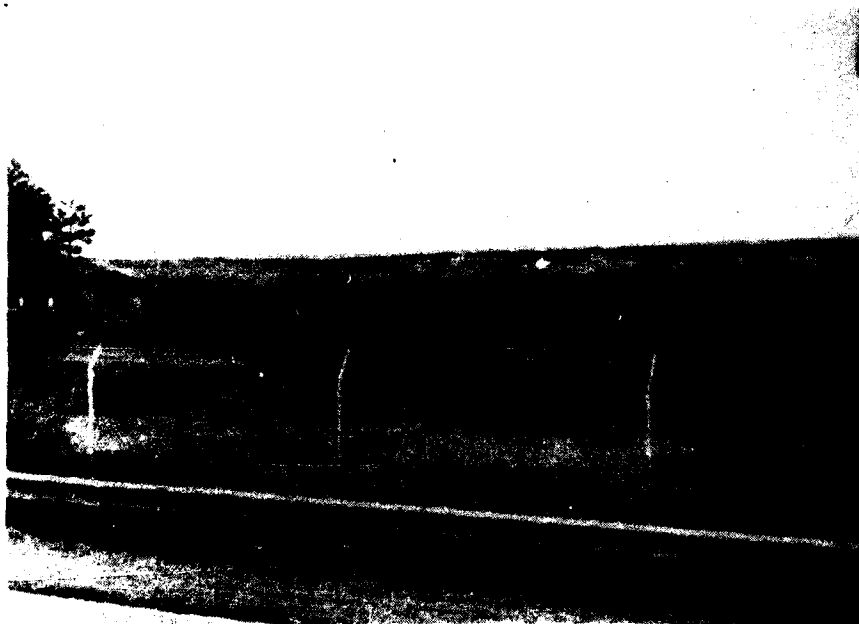
Photo 81 - Overview after site restoration (November 1985)
